# CONDITION SURVEY OF LOCK NO. 7, MONONGAHELA RIVER

May 1987  
Final Report

Prepared for US Army Engineer District, Pittsburgh  
Pittsburgh, Pennsylvania 15222-4186

CONDITION SURVEY OF LOCK NO. 7,  
MONONGAHELA RIVER

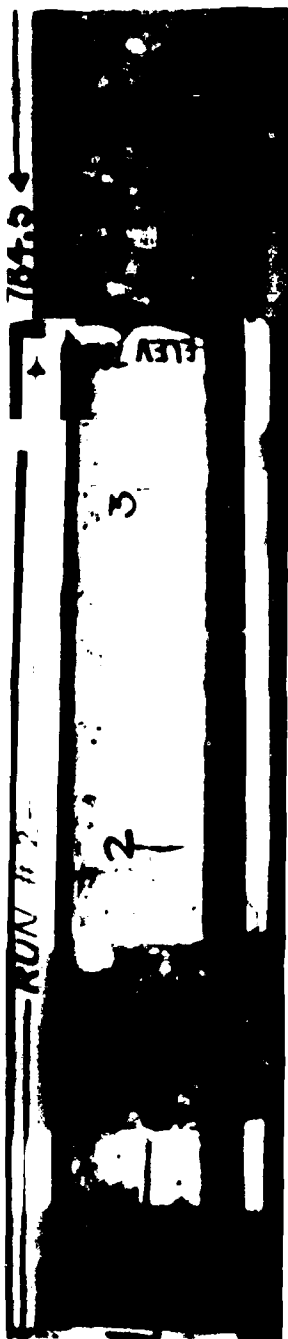
a. Concrete core, vertical boring 1-1-82, land lock wall

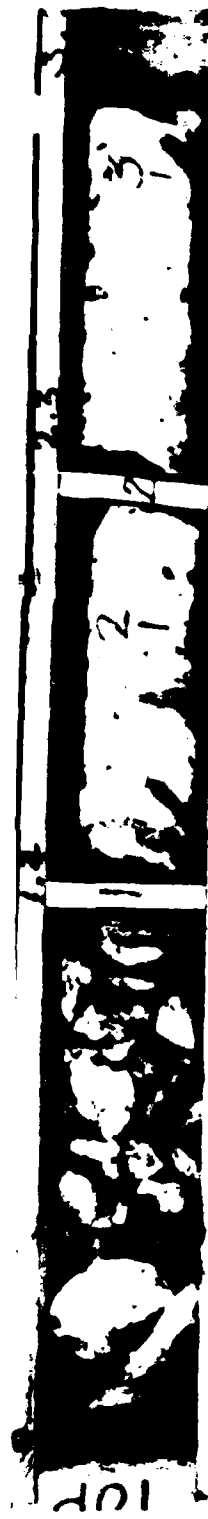
b. Concrete core, vertical boring 1-1-82, land lock wall

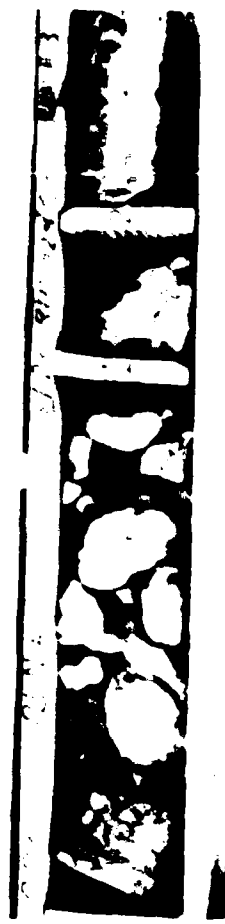
c. Concrete core, vertical boring 1-1-82, land lock wall

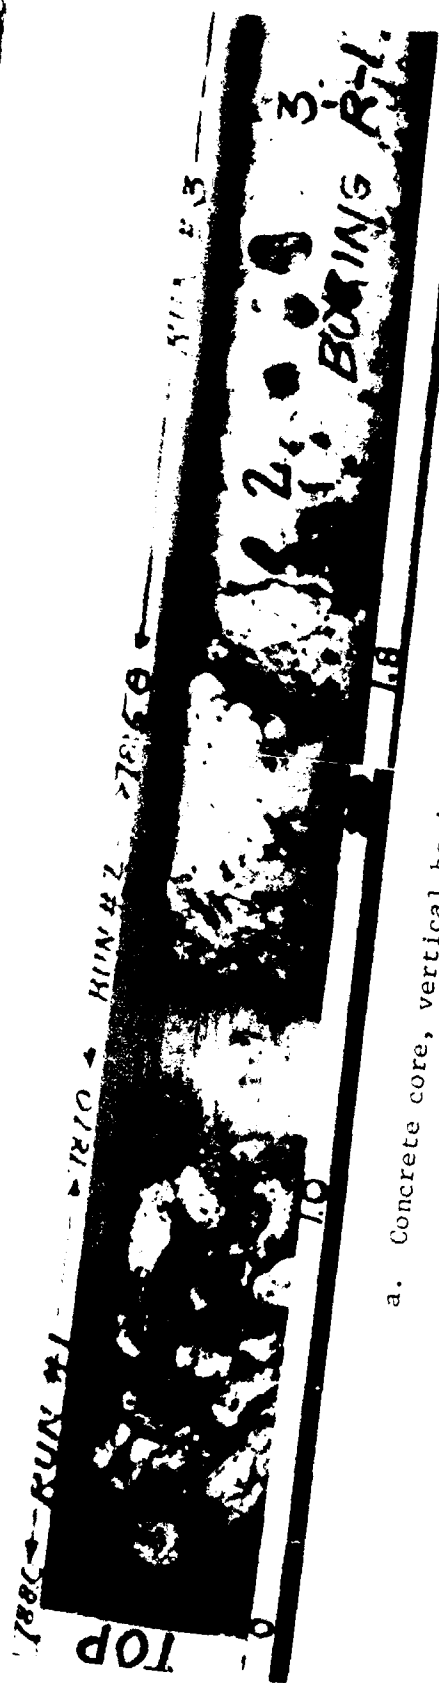
a. Concrete core, vertical boring R-1-82 river lock wall

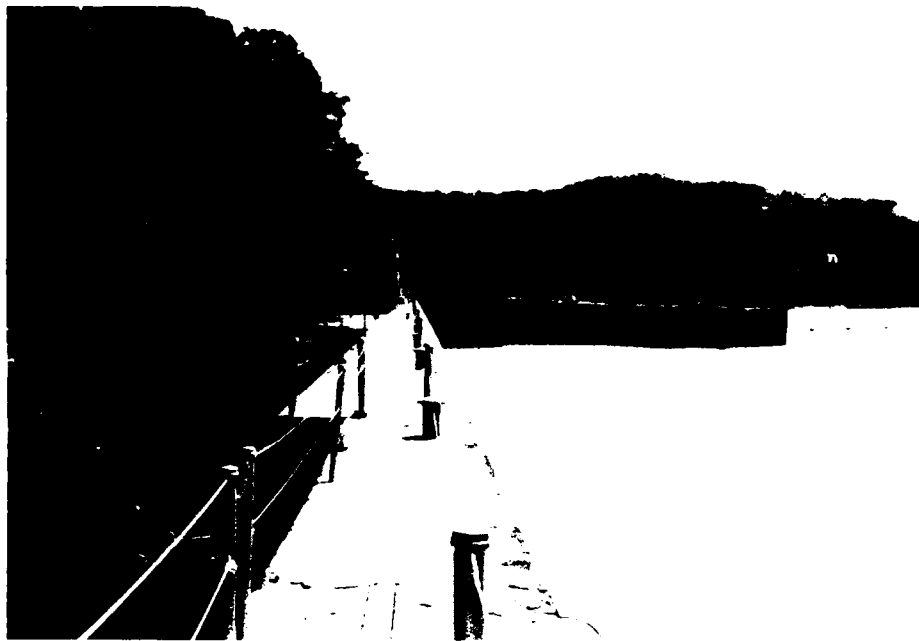
Photo 1. Top surface of upper guide wall looking downstream.

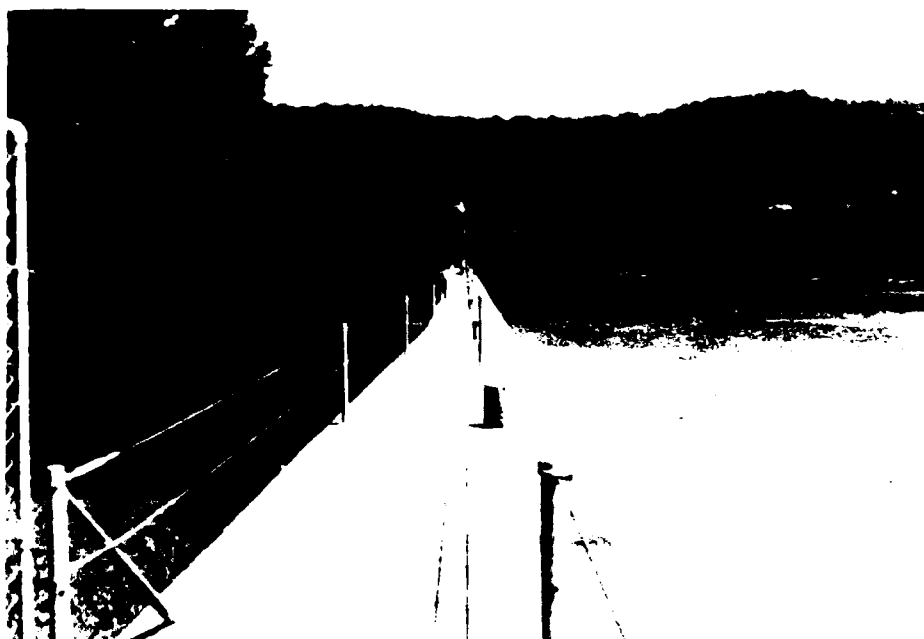
Photo 6. Top view of the lower guide wall looking downstream

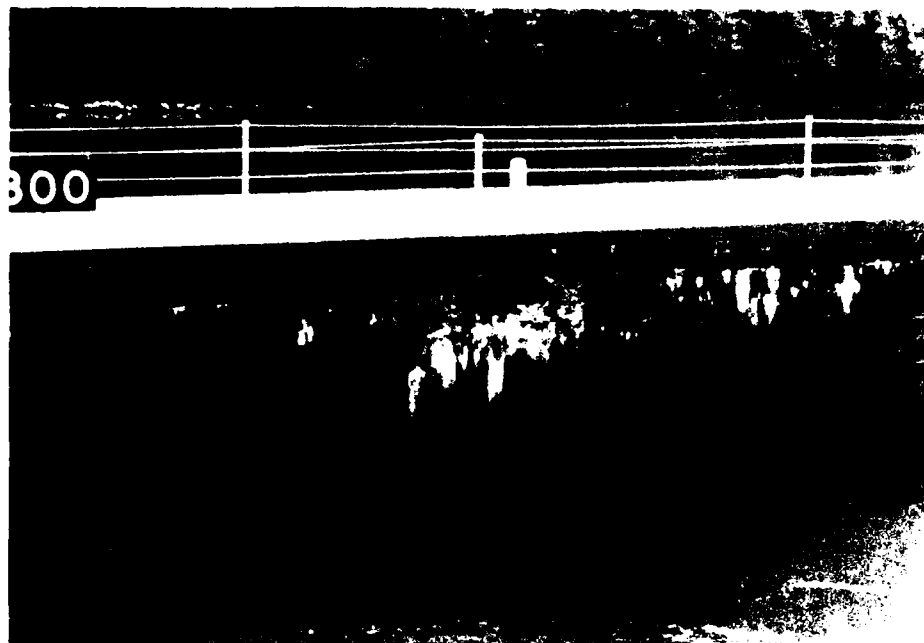
Photo 23. River lock wall looking riverward with chamber full

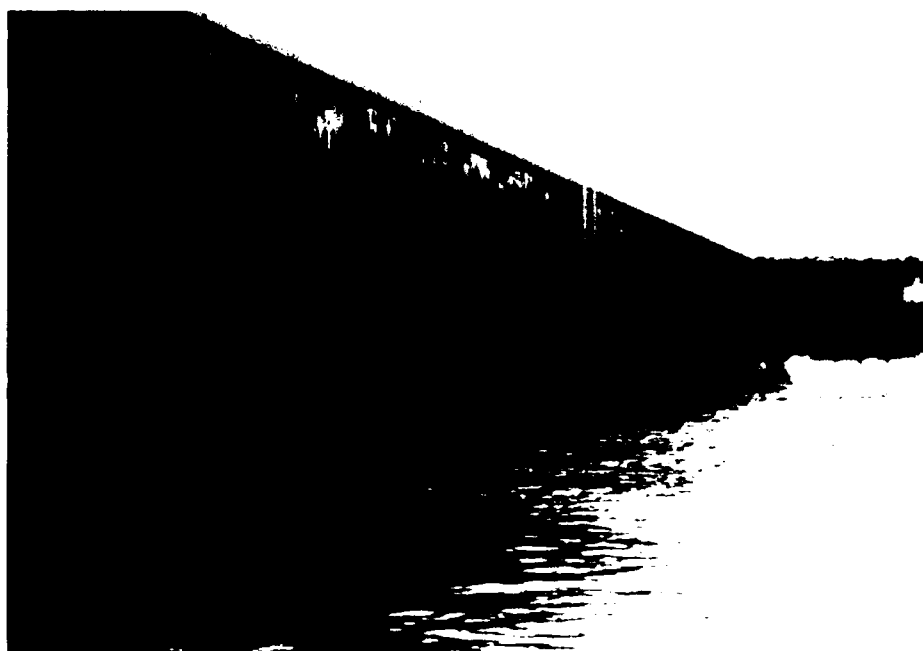
Photo 24. River lock wall looking upstream
